# DAISY CHAINS AND OTHER LANYARDS:

## Some Shocking Results when Shock Loaded

**Presented to:**
The International Technical Rescue Symposium
November 2005
Ft. Collins, CO
USA

**Presented by:**
Mike Gibbs
Rigging for Rescue
Ouray, Colorado
USA

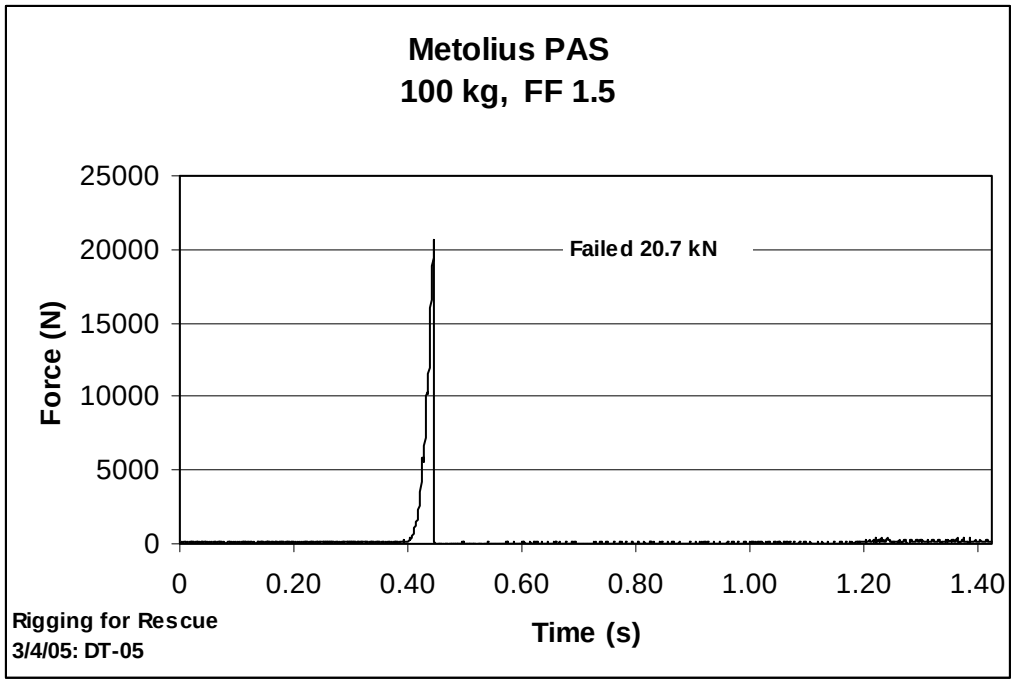
Metolius PAS
100 kg, FF 1.5
25000
20000
15000
10000
5000
0
Force (N)
Failed 20.7 kN
0
0.20
0.40
0.60
0.80
1.00
1.20
1.40
Time (s)
Rigging for Rescue
3/4/05: DT-05

| Test # | Lanyard Type: make, model, color | Lanyard Type: size, material & construction | Initial Unit Length (cm) | Mass (kg) | Drop Height (cm) | Fall Factor | Slide Distance (cm) | Final Unit Length (cm) | Maximum Arrest Force (N) |
|---|---|---|---|---|---|---|---|---|---|
| 5 | Metolius PAS | Dyneema; sewn | 99 | 100 | 148.5 | 1.5 | NA | **Failed** | 20661 |
| **Comments:** Failed in first link after the girth hitch at the load end. Failed in the webbing link - not the stitching. | | | | | | | | | |

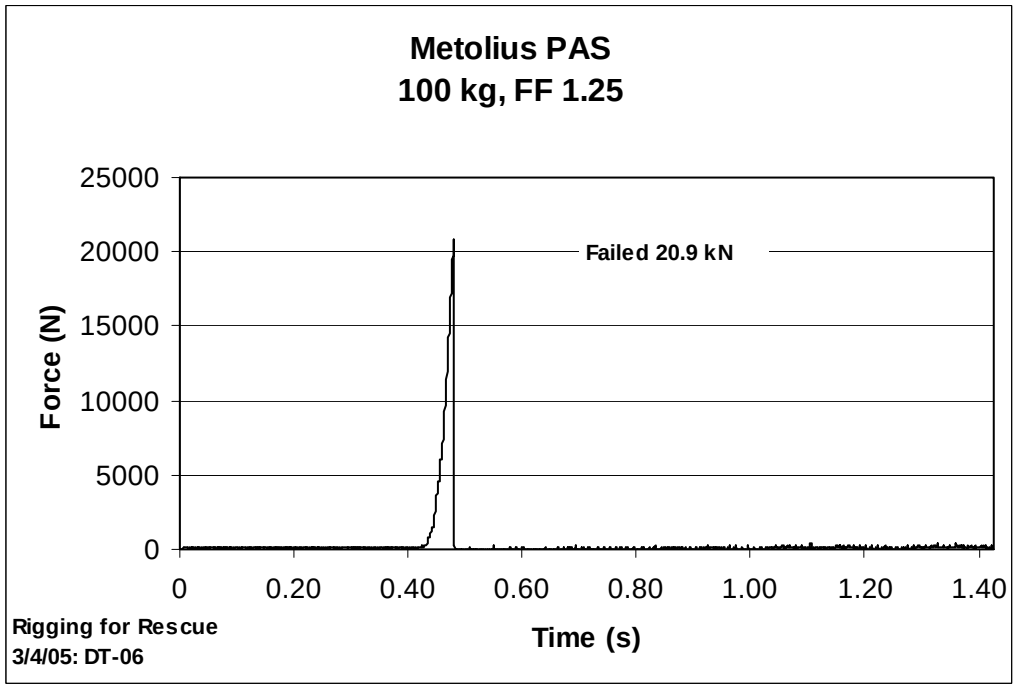
Metolius PAS
100 kg, FF 1.25
25000
20000
15000
10000
5000
0
Force (N)
Failed 20.9 kN
0
0.20
0.40
0.60
0.80
1.00
1.20
1.40
Time (s)
Rigging for Rescue
3/4/05: DT-06

| **Lanyard:** | **Fall Factor** | **MAF (kN)** | **Result** |
|---|---|---|---|
| Metolius PAS (2005 DT-6) | 1.25 | 20.9 | Failure |

| Test # | Lanyard Type: make, model, color | Lanyard Type: size, material & construction | Initial Unit Length (cm) | Mass (kg) | Drop Height (cm) | Fall Factor | Slide Distance (cm) | Final Unit Length (cm) | Maximum Arrest Force (N) |
|---|---|---|---|---|---|---|---|---|---|
| 6 | Metolius PAS | Dyneema; sewn | 99 | 100 | 123.8 | 1.25 | NA | **Failed** | 20900 |
| **Comments:** Same failure location as in drop test #5. | | | | | | | | | |

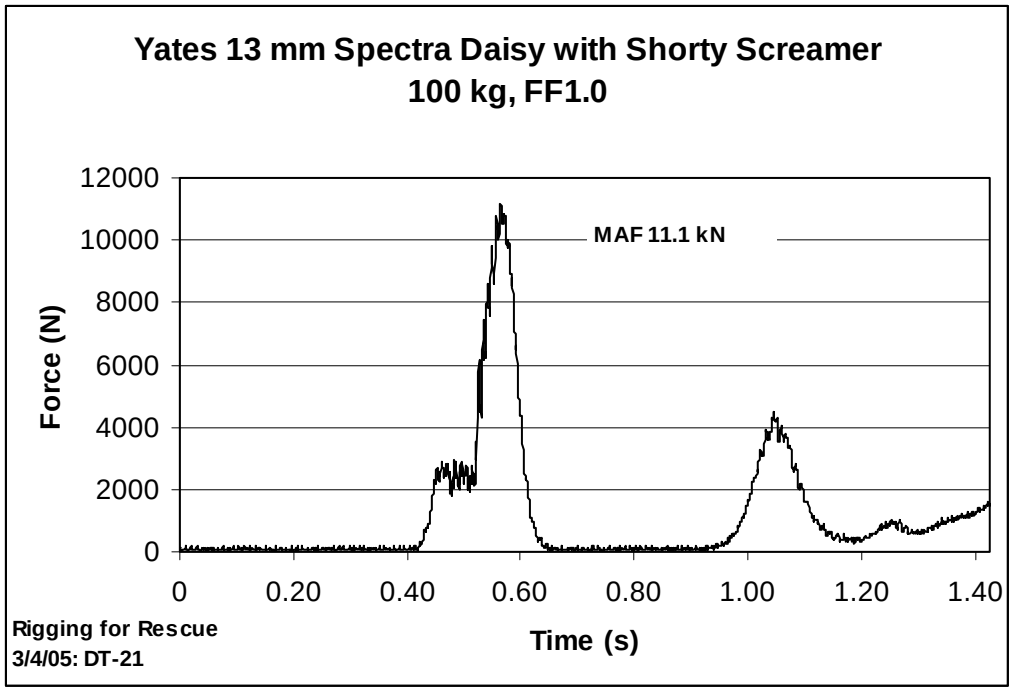
Yates 13 mm Spectra Daisy with Shorty Screamer
100 kg, FF1.0
MAF 11.1 kN
Force (N)
Time (s)
12000
10000
8000
6000
4000
2000
0
0
0.20
0.40
0.60
0.80
1.00
1.20
1.40
Rigging for Rescue
3/4/05: DT-21

| **Lanyard:** | **Fall Factor** | **MAF (kN)** | **Result** |
|---|---|---|---|
| Yates Spectra Daisy with Yates Shorty Screamer (2005 DT-21) | 1.0 | 11.1 | Catch (Shorty Screamer fully deployed; fibers separating at bar tack on daisy chain – near failure) |

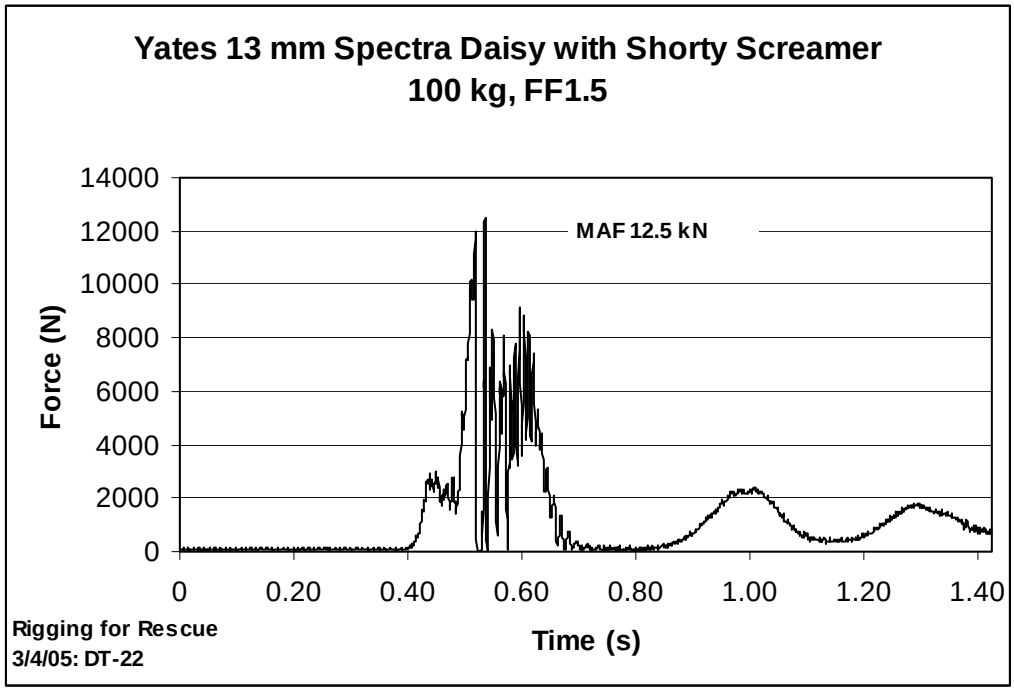
Yates 13 mm Spectra Daisy with Shorty Screamer
100 kg, FF1.5
MAF 12.5 kN
Force (N)
Time (s)
14000
12000
10000
8000
6000
4000
2000
0
0
0.20
0.40
0.60
0.80
1.00
1.20
1.40
Rigging for Rescue
3/4/05: DT-22

| Test # | Lanyard Type: make, model, color | Lanyard Type: size, material & construction | Initial Unit Length (cm) | Mass (kg) | Drop Height (cm) | Fall Factor | Slide Distance (cm) | Final Unit Length (cm) | Maximum Arrest Force (N) |
|---|---|---|---|---|---|---|---|---|---|
| 22 | Yates Daisy Chain w/ Shorty Screamer | 13mm; Spectra; sewn | 125 | 100 | 187.5 | 1.5 | NA | **Failed** | 12539 |
| **Comments:** Shorty Screamer fully deployed. Daisy failed in strand near Screamer girth hitch connection. Only the stub of bar tacking that wedged itself into the Screamer girth hitch connection prevented the load from grounding. | | | | | | | | | |

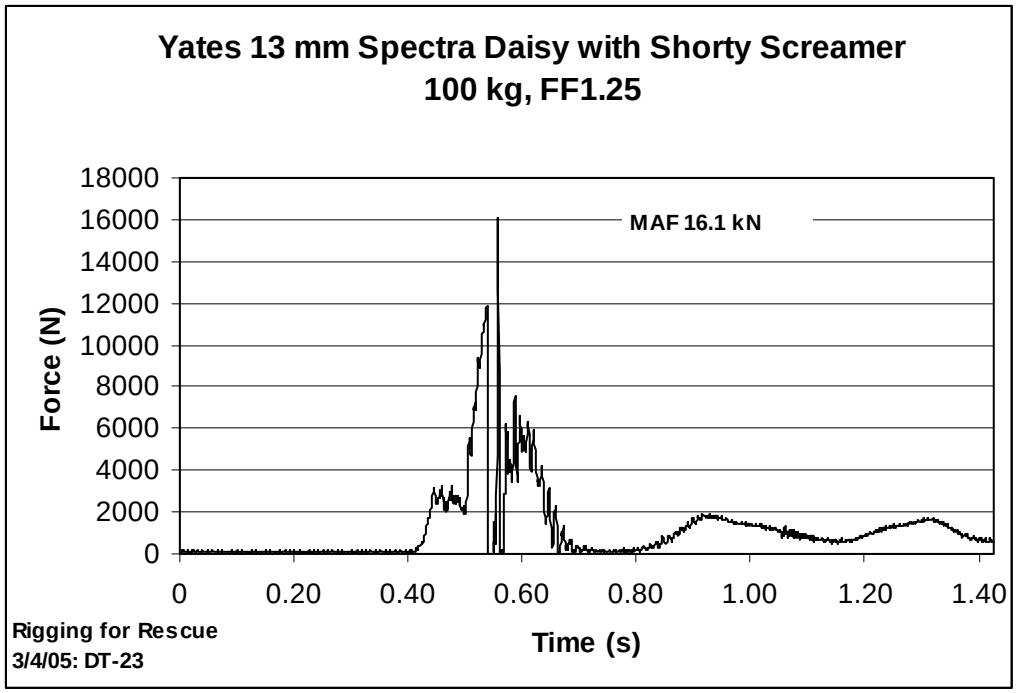
Yates 13 mm Spectra Daisy with Shorty Screamer
100 kg, FF1.25
MAF 16.1 kN
Force (N)
Time (s)
18000
16000
14000
12000
10000
8000
6000
4000
2000
0
0
0.20
0.40
0.60
0.80
1.00
1.20
1.40
Rigging for Rescue
3/4/05: DT-23

| **Lanyard:** | **Fall Factor** | **MAF (kN)** | **Result** |
|---|---|---|---|
| Yates Spectra Daisy with Yates Shorty Screamer (2005 DT-23) | 1.25 | 16.1 | Failure ( Shorty Screamer fully deployed) |

| Test # | Lanyard Type: make, model, color | Lanyard Type: size, material & construction | Initial Unit Length (cm) | Mass (kg) | Drop Height (cm) | Fall Factor | Slide Distance (cm) | Final Unit Length (cm) | Maximum Arrest Force (N) |
|---|---|---|---|---|---|---|---|---|---|
| 23 | Yates Daisy Chain w/ Shorty Screamer | 13mm; Spectra; sewn | 125 | 100 | 156.25 | 1.25 | NA | **Failed** | 16110 |

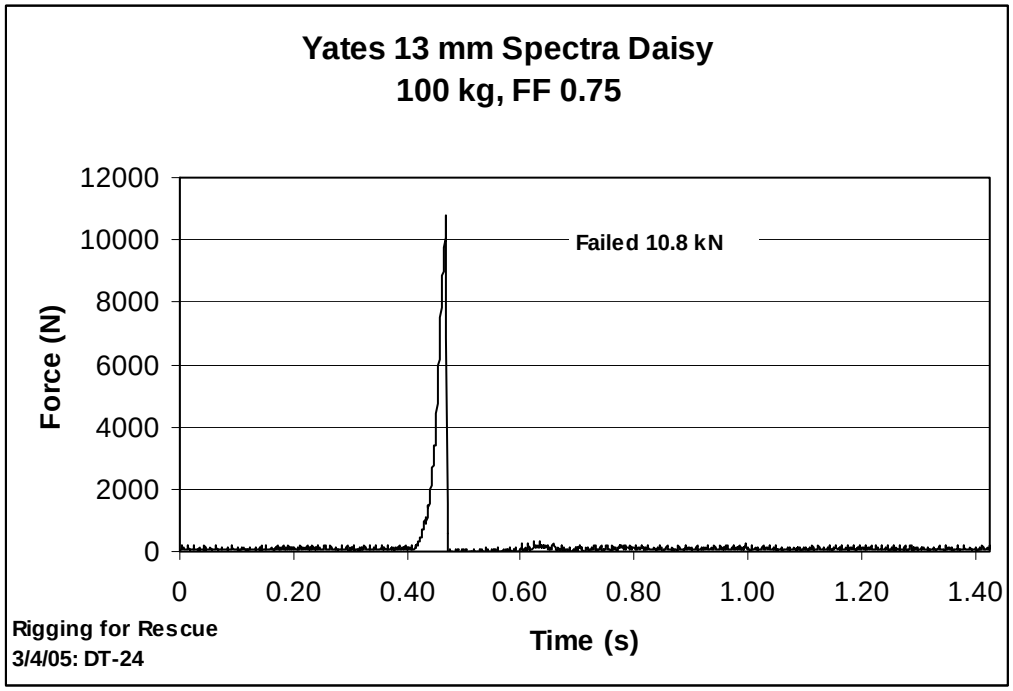
Yates 13 mm Spectra Daisy
100 kg, FF 0.75
Failed 10.8 kN
Force (N)
Time (s)
12000
10000
8000
6000
4000
2000
0
0
0.20
0.40
0.60
0.80
1.00
1.20
1.40
Rigging for Rescue
3/4/05: DT-24

| Test # | Lanyard Type: make, model, color | Lanyard Type: size, material & construction | Initial Unit Length (cm) | Mass (kg) | Drop Height (cm) | Fall Factor | Slide Distance (cm) | Final Unit Length (cm) | Maximum Arrest Force (N) |
|---|---|---|---|---|---|---|---|---|---|
| 24 | Yates Daisy Chain {no Shorty Screamer} | 13mm; Spectra; sewn | 115 | 100 | 86.5 | 0.75 | NA | **Failed** | 10800 |
| **Comments:** Failed in a bar tacked location. | | | | | | | | | |

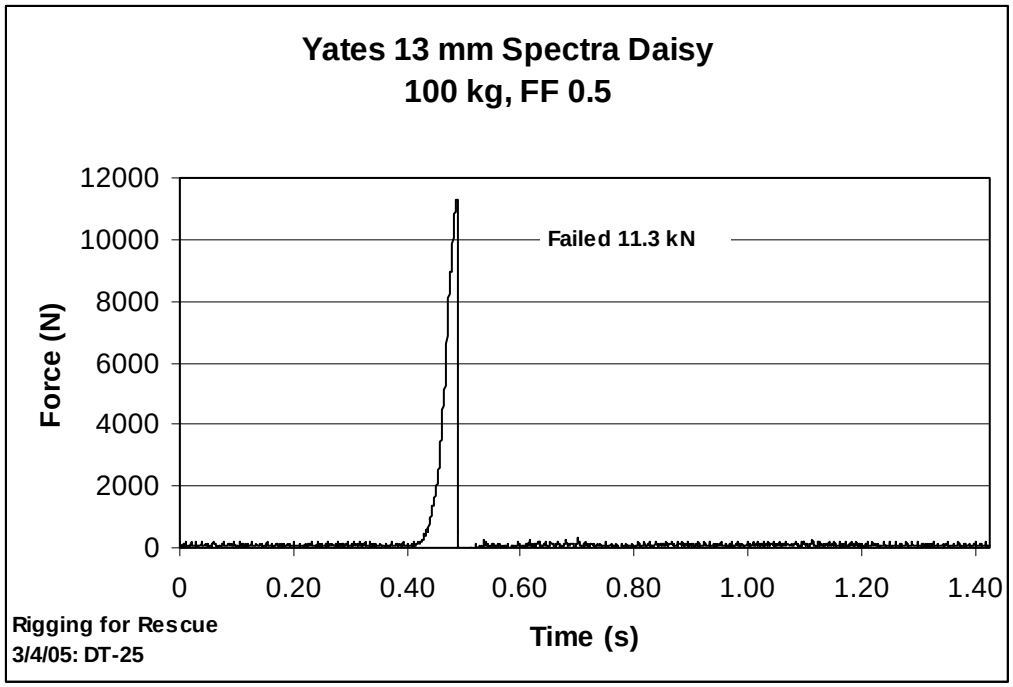
Yates 13 mm Spectra Daisy
100 kg, FF 0.5
Failed 11.3 kN
Force (N)
Time (s)
12000
10000
8000
6000
4000
2000
0
0
0.20
0.40
0.60
0.80
1.00
1.20
1.40
Rigging for Rescue
3/4/05: DT-25

| **Lanyard:** | **Fall Factor** | **MAF (kN)** | **Result** |
|---|---|---|---|
| Yates Spectra Daisy (2005 DT-25) | 0.5 | 11.3 | Failure |

| Test # | Lanyard Type: make, model, color | Lanyard Type: size, material & construction | Initial Unit Length (cm) | Mass (kg) | Drop Height (cm) | Fall Factor | Slide Distance (cm) | Final Unit Length (cm) | Maximum Arrest Force (N) |
|---|---|---|---|---|---|---|---|---|---|
| 25 | Yates Daisy Chain {no Shorty Screamer} | 13mm; Spectra; sewn | 115 | 100 | 57.5 | 0.5 | NA | **Failed** | 11307 |
| **Comments:** Failed. | | | | | | | | | |

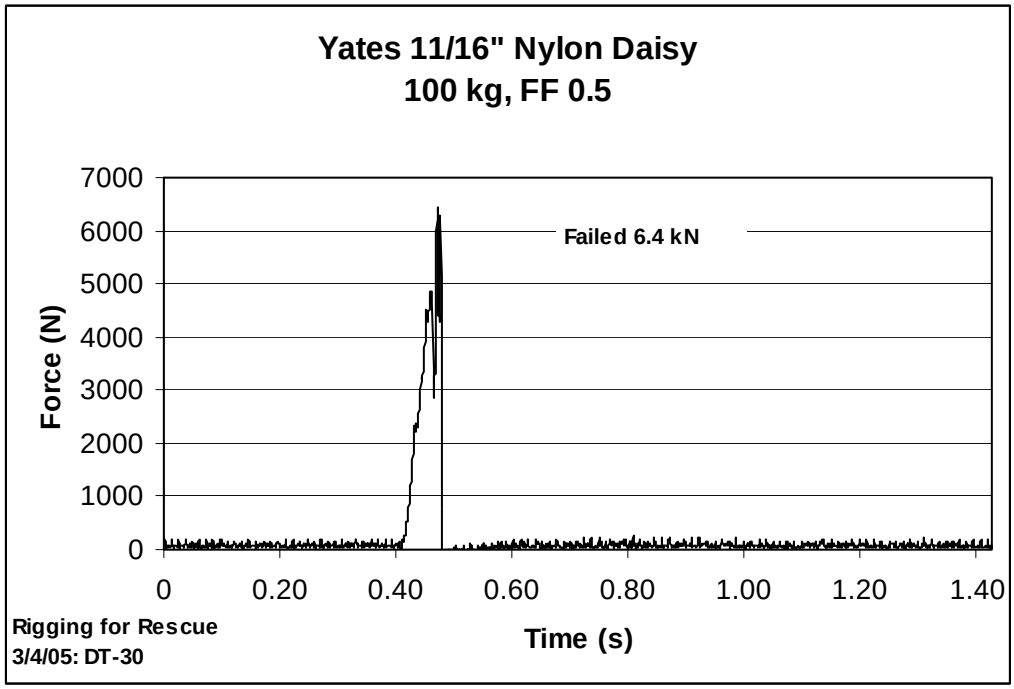
Yates 11/16" Nylon Daisy
100 kg, FF 0.5
Failed 6.4 kN
Force (N)
7000
6000
5000
4000
3000
2000
1000
0
0
0.20
0.40
0.60
0.80
1.00
1.20
1.40
Time (s)
Rigging for Rescue
3/4/05: DT-30

| Test # | Lanyard Type: make, model, color | Lanyard Type: size, material & construction | Initial Unit Length (cm) | Mass (kg) | Drop Height (cm) | Fall Factor | Slide Distance (cm) | Final Unit Length (cm) | Maximum Arrest Force (N) |
|---|---|---|---|---|---|---|---|---|---|
| 30 | Yates Daisy Chain | 11/16"; Nylon; sewn | 87 | 100 | 43.5 | 0.5 | NA | **Failed** | 6434 |
| **Comments:** Same set up as drop tests #27 - 29. Failed. | | | | | | | | | |
